# EXAMPLE- Site Recording Form

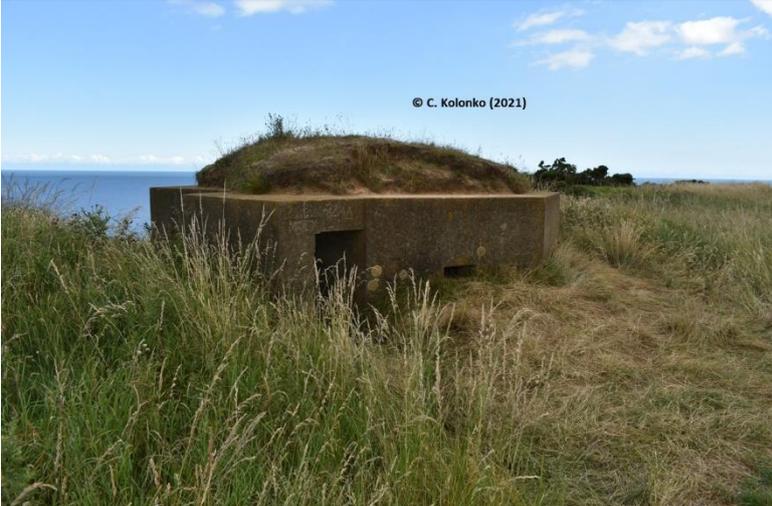
Photo Number	File Name eg DSC_2134	Description direction, feature in photograph, caption	Image
1	DSC_1000	General location and form of pillbox at time of survey. Image facing East, showing South-West and North-West facing elevations, and entrance.

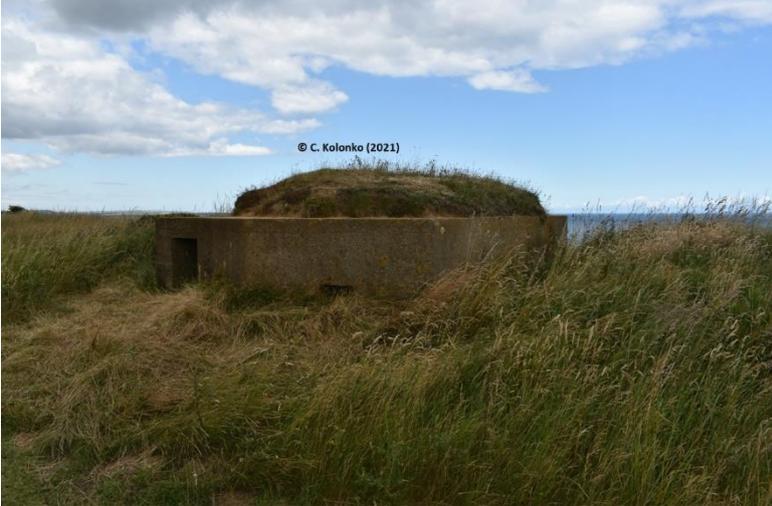
<p>A photograph of a circular pillbox with a grassy roof, viewed from an eastern perspective. The pillbox is situated in a field of tall grass with the ocean visible in the background under a blue sky with light clouds. A small black rectangular entrance is visible on the side of the pillbox. A copyright notice '© C. Kolonko (2021)' is centered in the upper part of the image.</p>
2	DSC_1001	General location and form of pillbox at time of survey. Image facing North, showing South and South-East facing elevations.

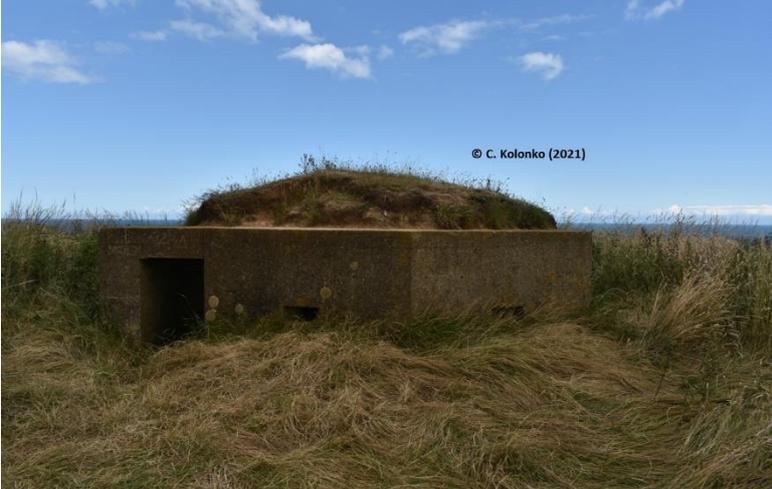
3	DSC_1002	Surviving extent of vegetation camouflage applied to roof of pillbox. Image taken facing North-East, showing entrance and South-West and South facing elevations.

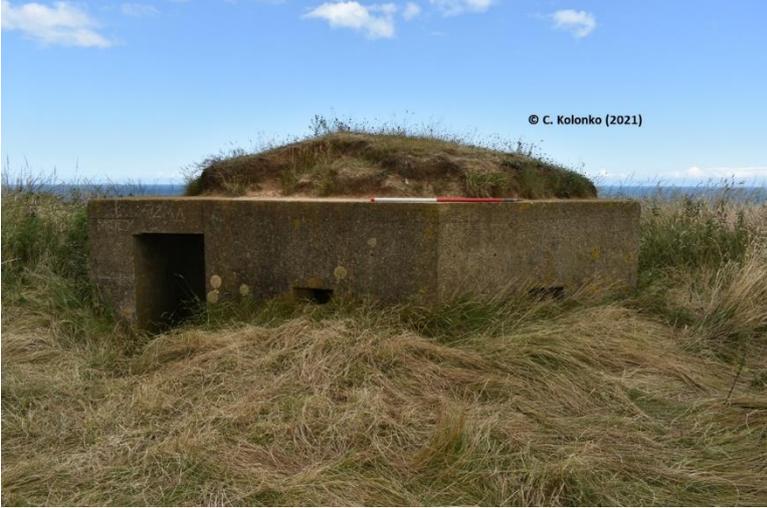
<p><b>4</b></p>	<p>DSC_1003</p>	<p>Surviving extent of vegetation camouflage applied to roof of pillbox. Image taken facing North-East, showing entrance and South-West and South facing elevations. 1m scale</p>

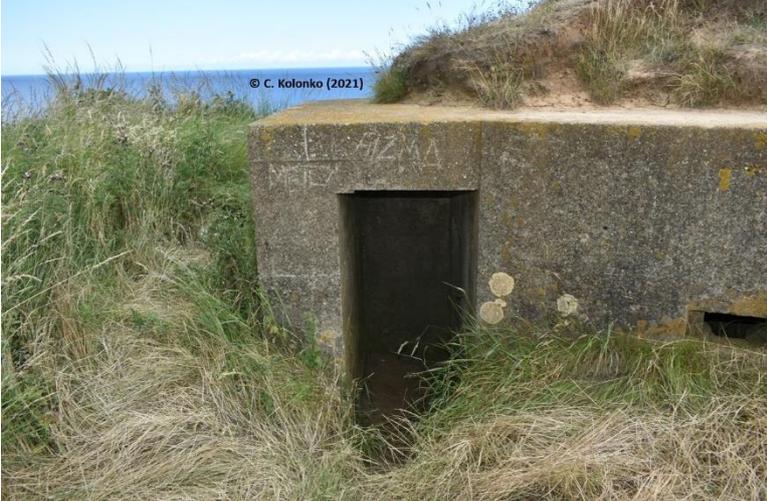
<p><b>5</b></p>	<p>DSC_1004</p>	<p>Image facing North-East showing South-West facing entrance.</p>

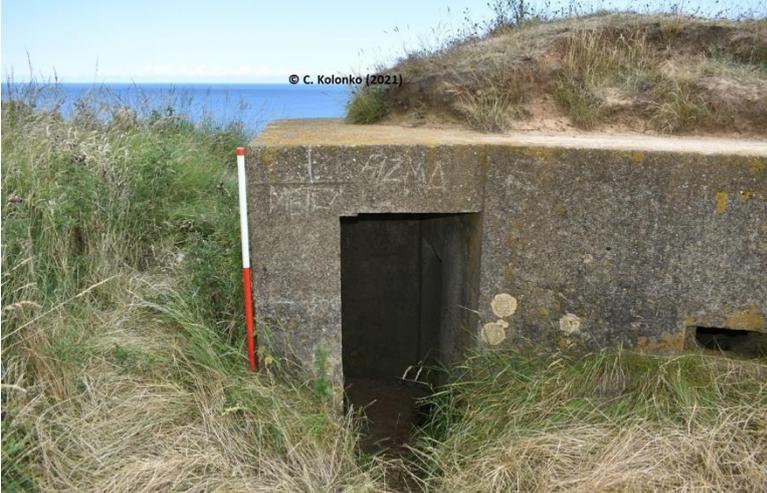
<p><b>6</b></p>	<p>DSC_1005</p>	<p>Image facing North-East showing South-West facing entrance with 1m scale. Note thickness of the roof and wall.</p>

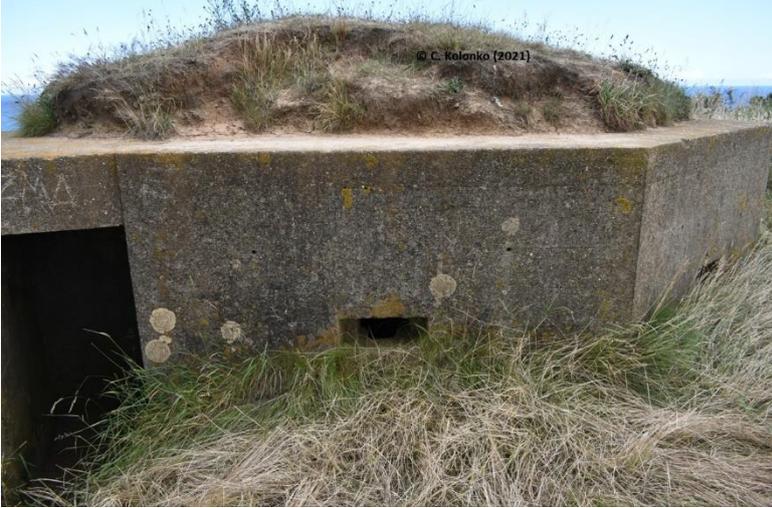
7	DSC_1006	South-West facing elevation. Showing LMG loophole. Image taken facing North-East

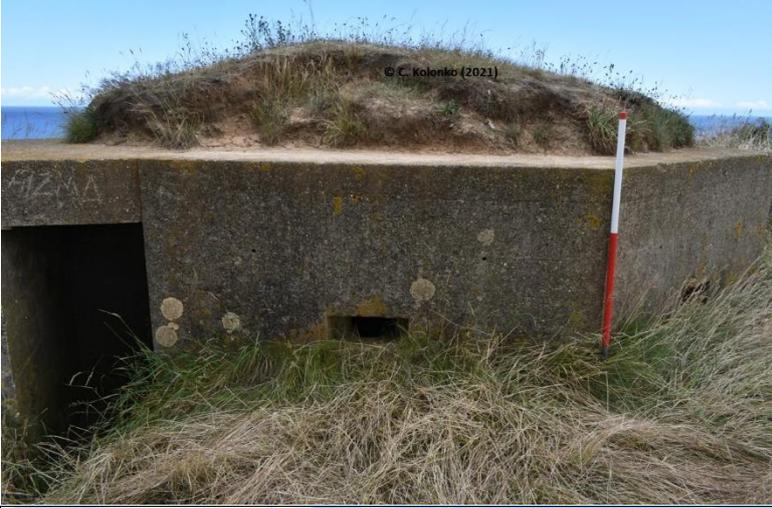
<p>A photograph showing the south-west facing elevation of a concrete bunker. The bunker has a dark, rectangular opening on the left and a smaller, square-shaped loophole in the center. The top of the bunker is covered in dry grass and some small plants. The background shows a clear blue sky and a distant horizon.</p>	
8	DSC_1007	South-West facing elevation with 1m scale. Showing LMG loophole. Image taken facing North-East.

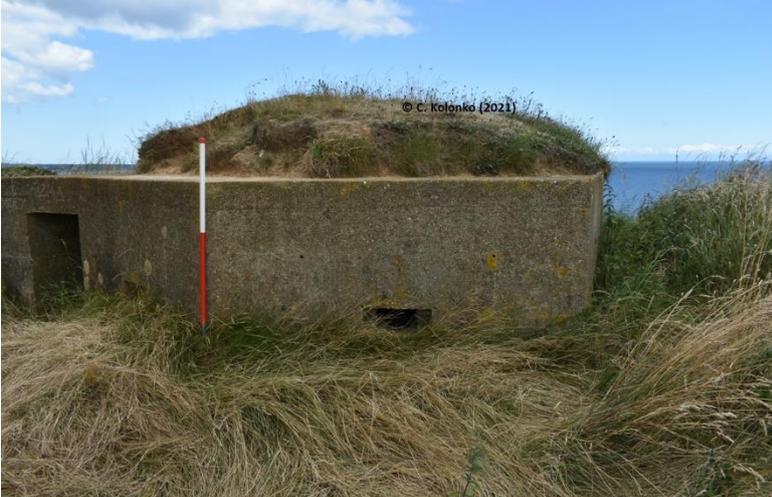
9	DSC_1008	South facing elevation with 1m scale. Showing LMG loophole. Image taken facing North.

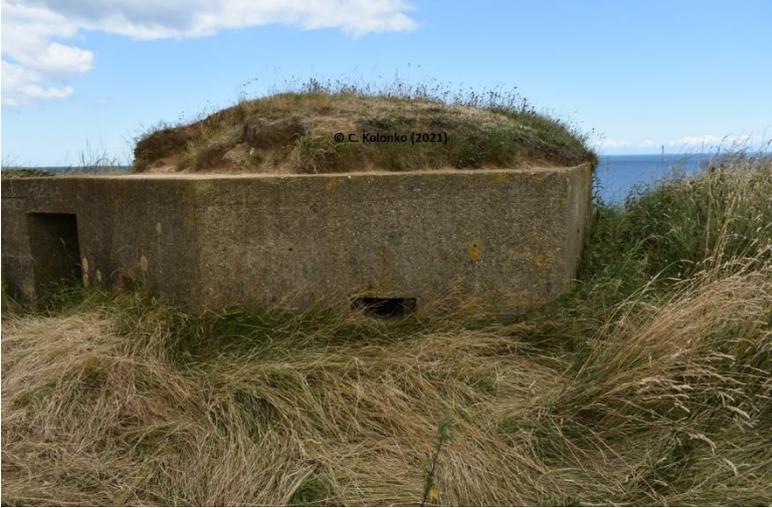
<p><b>10</b></p>	<p>DSC_1009</p>	<p>South facing elevation. Showing LMG loophole. Image taken facing North.</p>

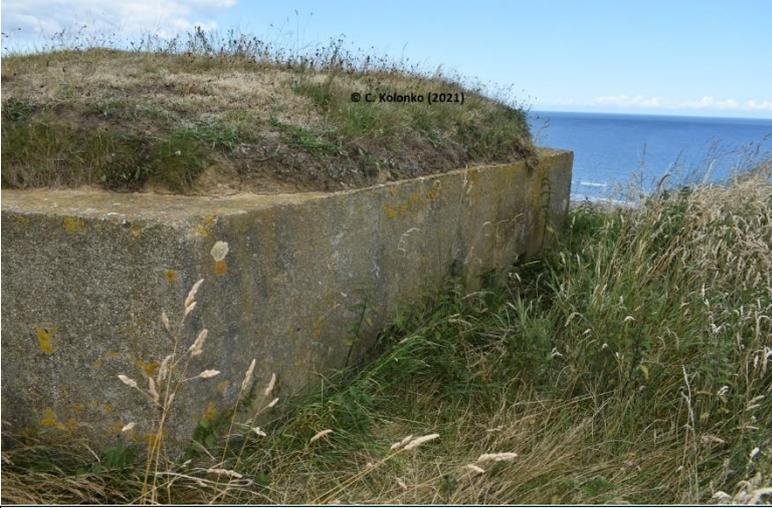
<p>A photograph of a circular concrete bunker with a grassy top. A small, dark rectangular opening (the LMG loophole) is visible on the side of the bunker. The bunker is surrounded by tall, dry grass. In the background, the blue sea and a clear sky are visible. A small copyright notice '© C. Kolonko (2021)' is present in the upper right of the image.</p>
<p><b>11</b></p>	<p>DSC_1010</p>	<p>South-East facing elevation showing rifle loopholes and vegetation growth. Image taken facing North.</p>

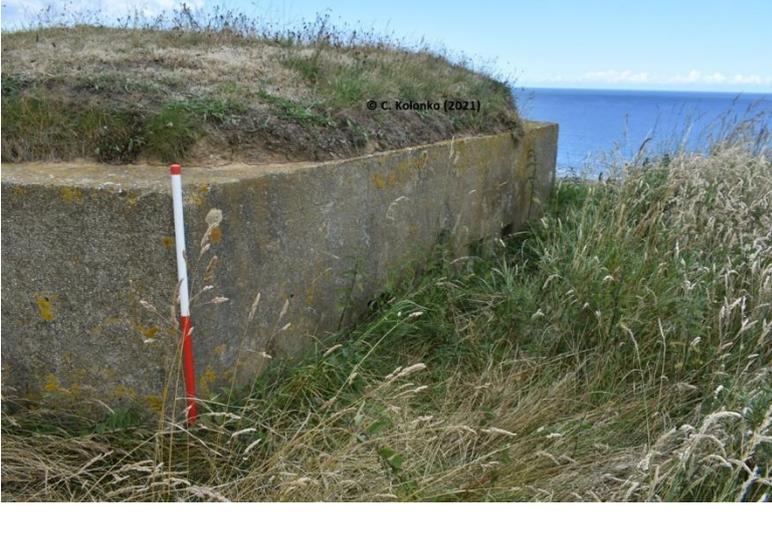
<p><b>12</b></p>	<p>DSC_1011</p>	<p>South-East facing elevation showing rifle loopholes and vegetation growth. Image taken facing North with 1m scale. (Note that the scale isn't properly vertical and is now bugging me)</p>

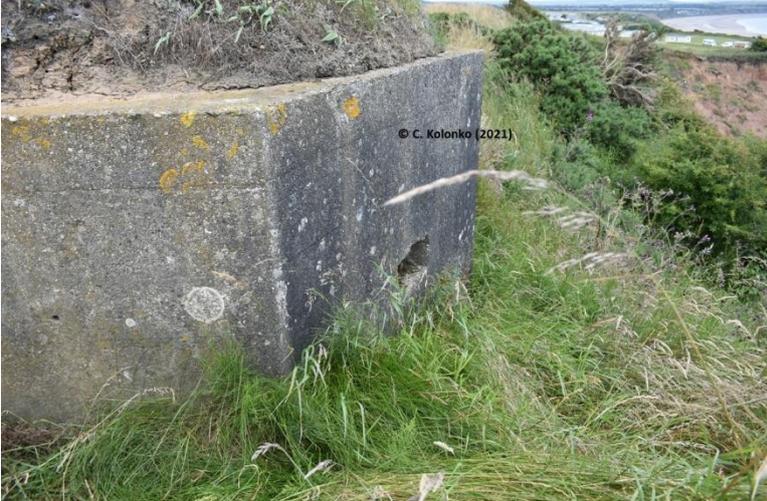
13	DSC_1012	North-East facing elevation showing LMG loophole. Image facing West

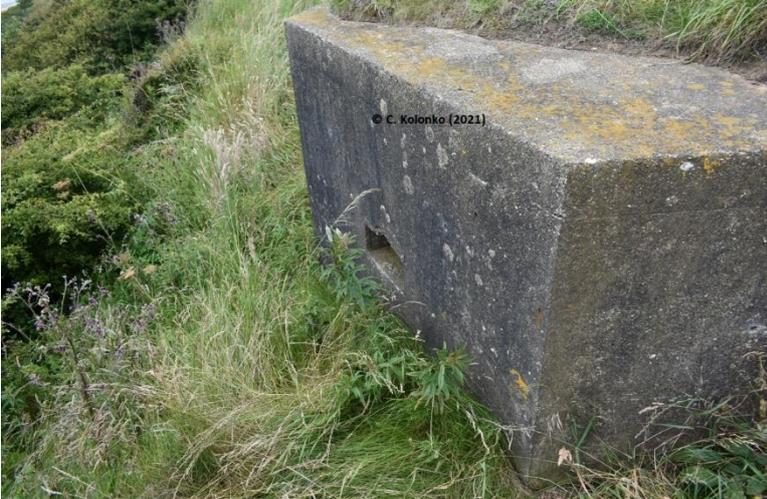
14	DSC_1013	North facing elevation showing LMG loophole. Image facing East

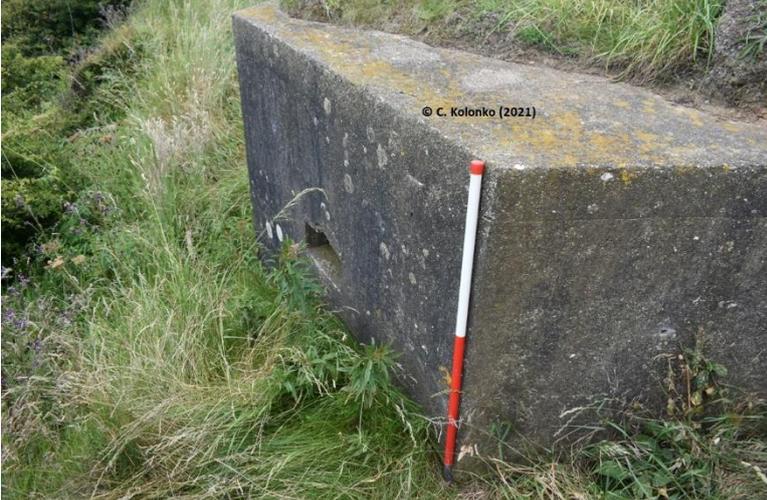
15	DSC_1014	North facing elevation showing LMG loophole. Image facing East. With 1m scale

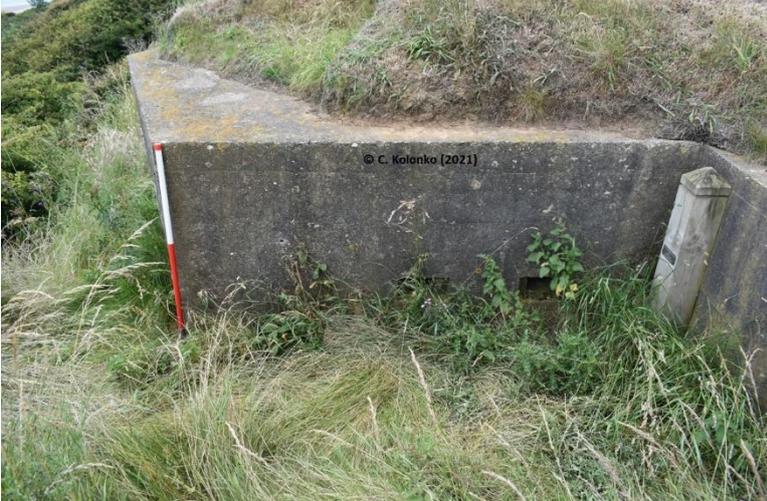
<p><b>16</b></p>	<p>DSC_1015</p>	<p>North-West facing elevation showing pair of rifle loopholes with 1m scale.</p>

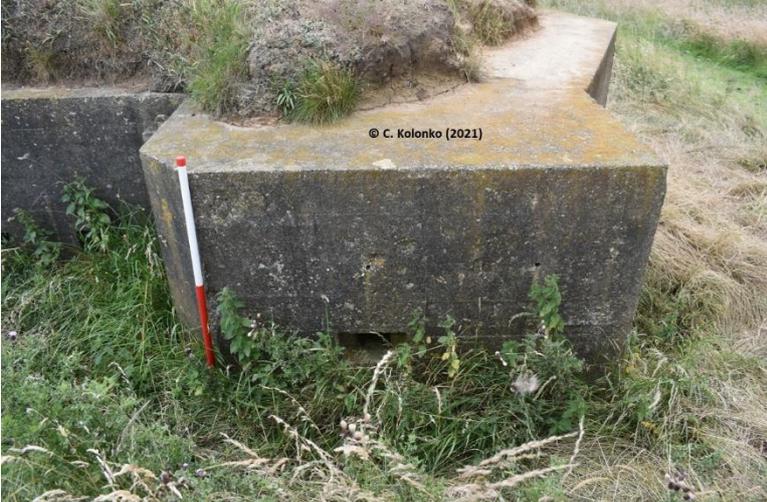
<p><b>17</b></p>	<p>DSC_1016</p>	<p>North-West facing elevation of entrance showing single rifle loophole and chamfered corner with 1m scale.</p>

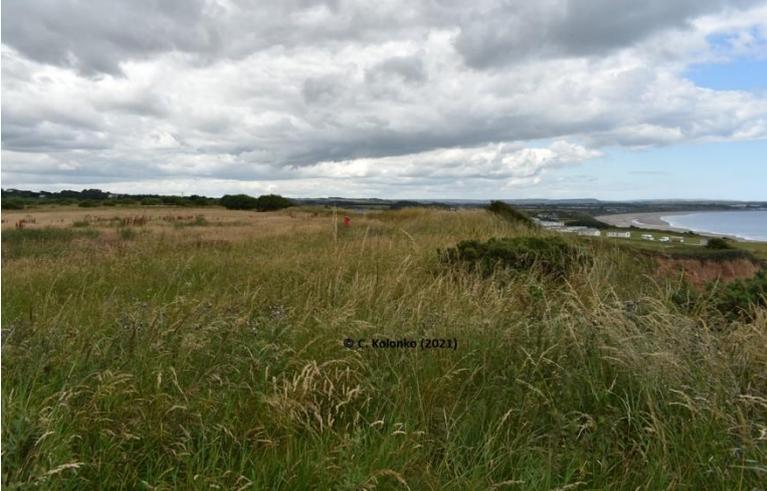
<p><b>18</b></p>	<p>DSC_1017</p>	<p>Panorama showing the North-West view from the pillbox's North-West facing loopholes. Image taken facing North-West in direction of nearby secondary pillbox.</p>

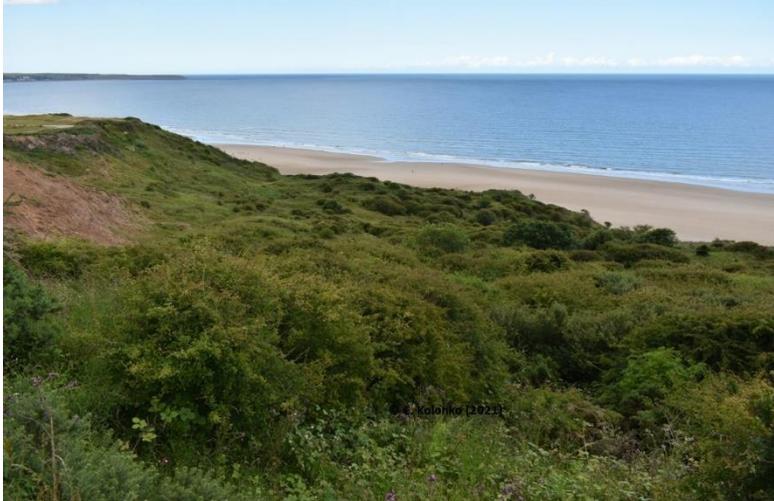
19	DSC_1018	<p>Panorama showing the North view from the pillbox's North loophole. Image taken facing North in direction of the beach and approaches to the position.</p>

<p>A panoramic photograph showing a view from a pillbox's North loophole. The foreground is dominated by dense green vegetation. In the middle ground, a sandy beach stretches across the frame, leading to the blue sea under a clear sky. A small copyright notice '© C. Kolonko (2021)' is visible in the lower right of the image.</p>	
20	DSC_1019	<p>Panorama showing the North-East view from the pillbox's North-East loophole. Image taken facing North-East in direction of the beach and approaches to the position.</p>

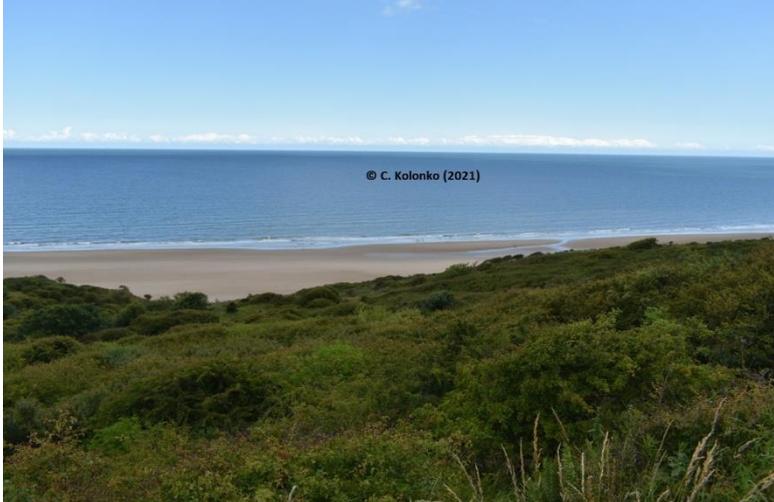
<p>A panoramic photograph showing a view from a pillbox's North-East loophole. The foreground is filled with green vegetation. The middle ground shows a sandy beach and the blue sea. The sky is clear with a few clouds. A small copyright notice '© C. Kolonko (2021)' is visible in the center of the image.</p>

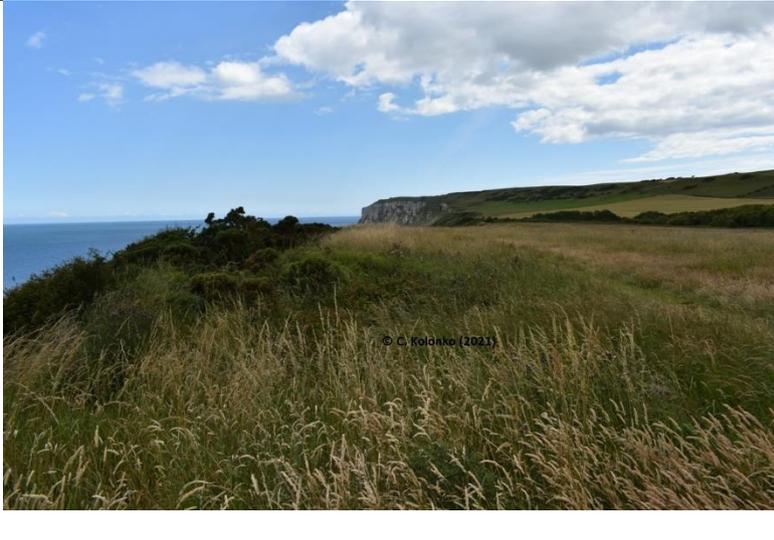
21	DSC_1020	<p>Panorama showing the South-East view from the pillbox's South-East facing loopholes. Image taken facing South-East in direction of the cliff edge and approaches to the position.</p>

<p>A panoramic photograph showing a view from a pillbox's South-East facing loopholes. The foreground is dominated by tall, golden-brown grasses. In the middle ground, a cliff edge is visible, leading to the blue sea. The sky is blue with scattered white clouds. A small copyright notice '© C. Kolonko (2021)' is visible in the lower right of the image.</p>

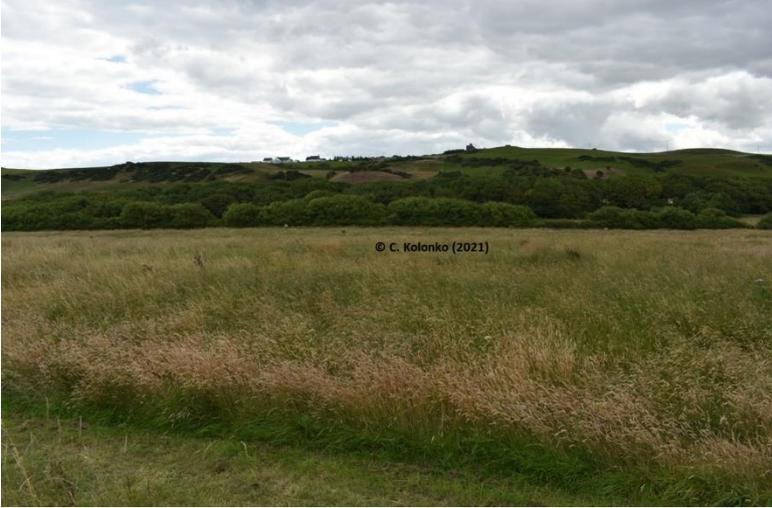
<p><b>22</b></p>	<p>DSC_1021</p>	<p>Panorama showing the South view from the pillbox's South loophole. Image taken facing South in direction of Speeton, showing nearby pillboxes occupying high ground and approaches to the position.</p>

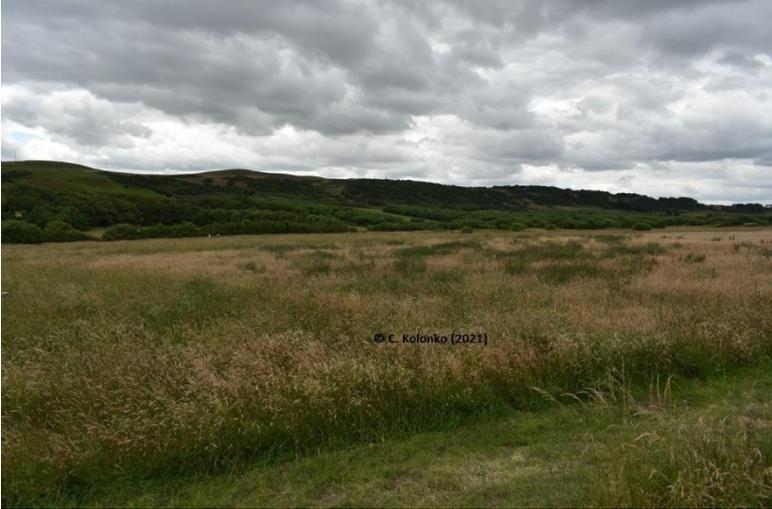
<p><b>23</b></p>	<p>DSC_1022</p>	<p>Panorama showing the South-West view from the pillbox's South-West facing loophole. Image taken in direction of the high ground West of Speeton showing approaches to the position.</p>

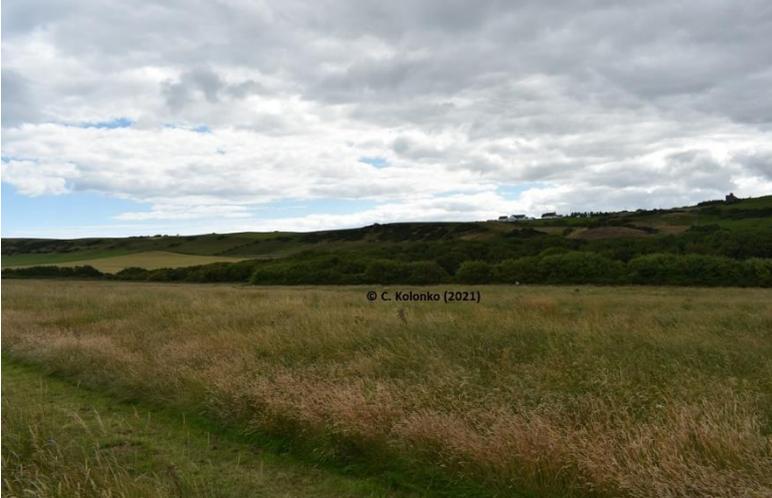
<p><b>24</b></p>	<p>DSC_1023</p>	<p>Panorama facing South-East centred on supporting pillbox 600m away on high ground to East of Speeton.</p>

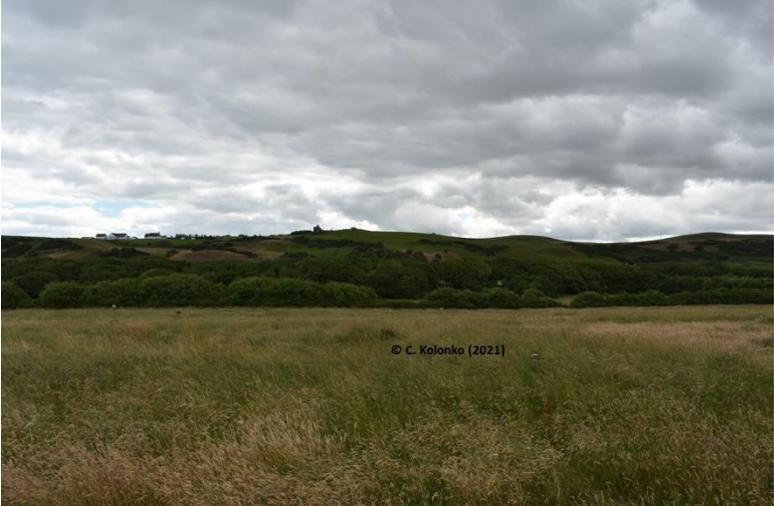
25	DSC_1024	Panorama facing South centred on supporting pillbox 680m away on high ground to West of Speeton

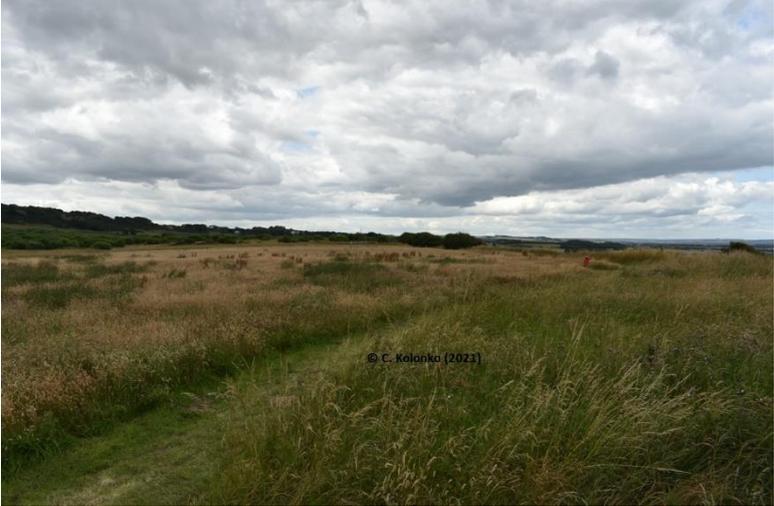
<p>© C. Kolonko (2021)</p>	
26	DSC_1025	Panorama facing West centred on supporting pillbox 420m away within hedgerow to the West.

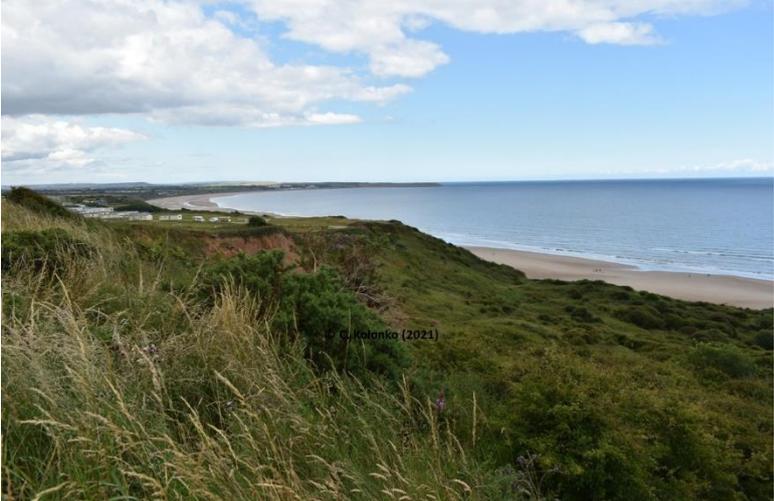
<p>© C. Kolonko (2021)</p>	
27	DSC_1026	Panorama facing North-West centred on site of adjacent pillbox 409m away on cliff edge.

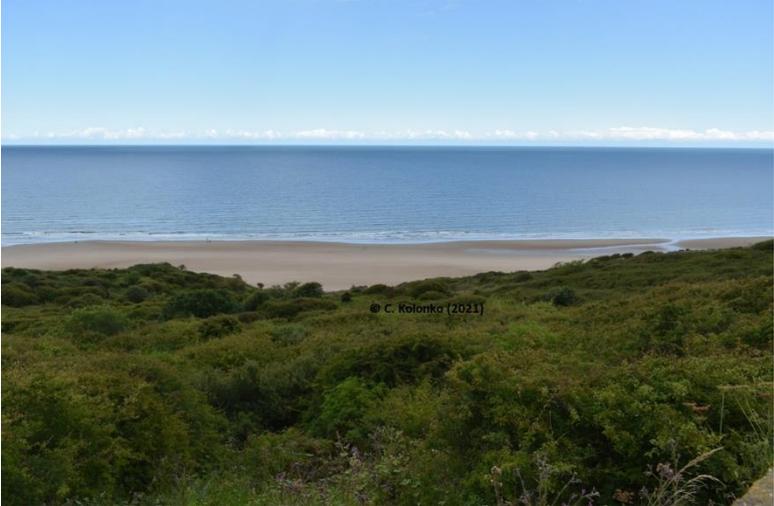
28	DSC_1027	Panorama facing North showing beach 287m below with approaches to the pillbox.

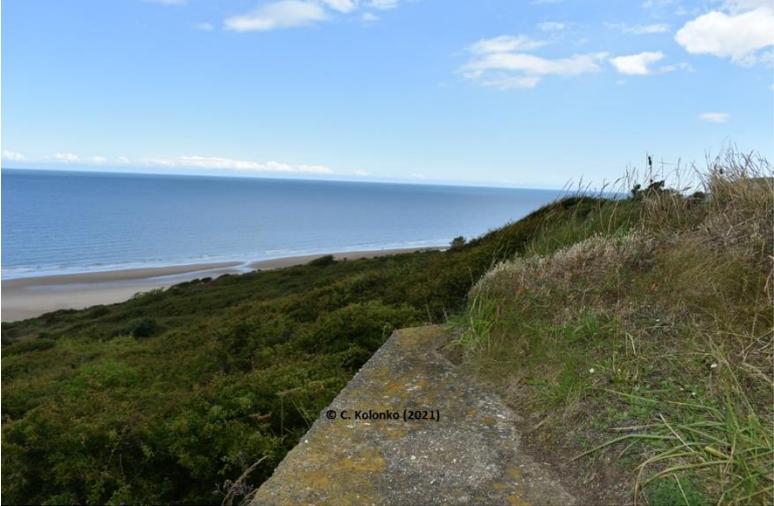
29	DSC_1028	Panorama facing North-East showing beach 380m below, overlooking anti-tank obstacle on the beach, with approaches to the pillbox.

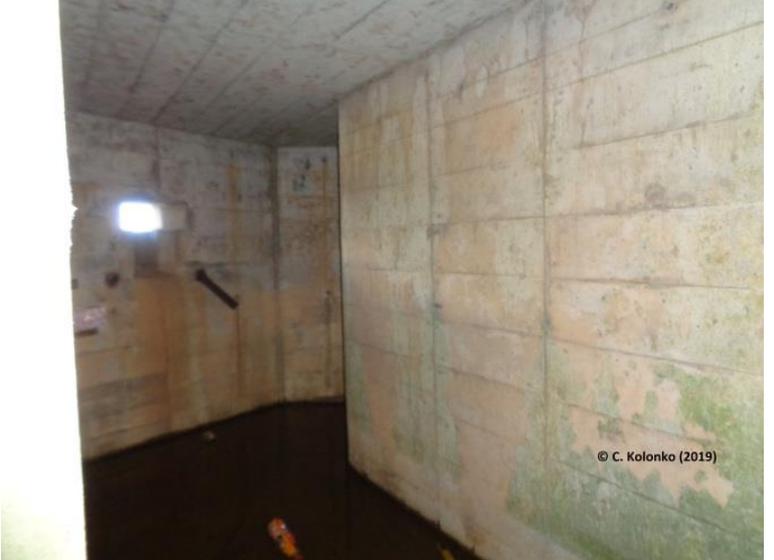
30	DSC_1029	Interior facing North, showing internal anti-ricochet wall and interior of North facing LMG embrasure.

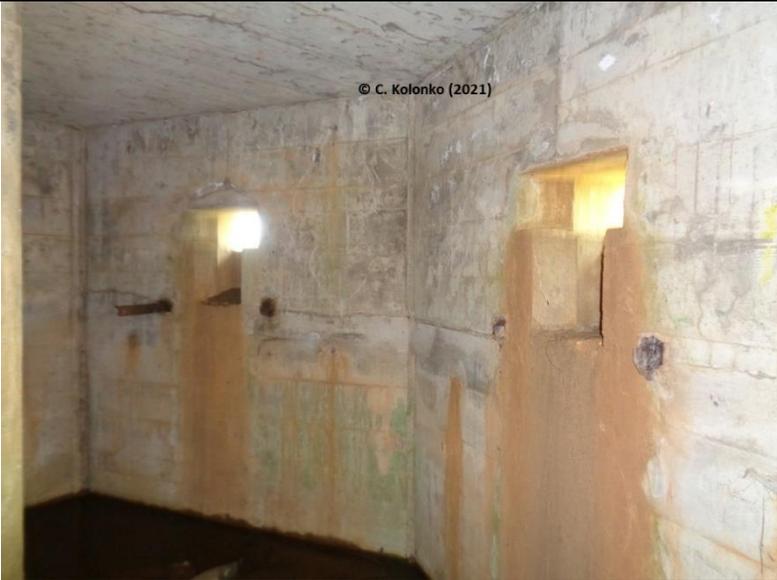
<p><b>31</b></p>	<p>DSC_1030</p>	<p>Interior facing South, showing internal South and South-West facing LMG embrasures. Note bar below loophole that once held a shelf.</p>

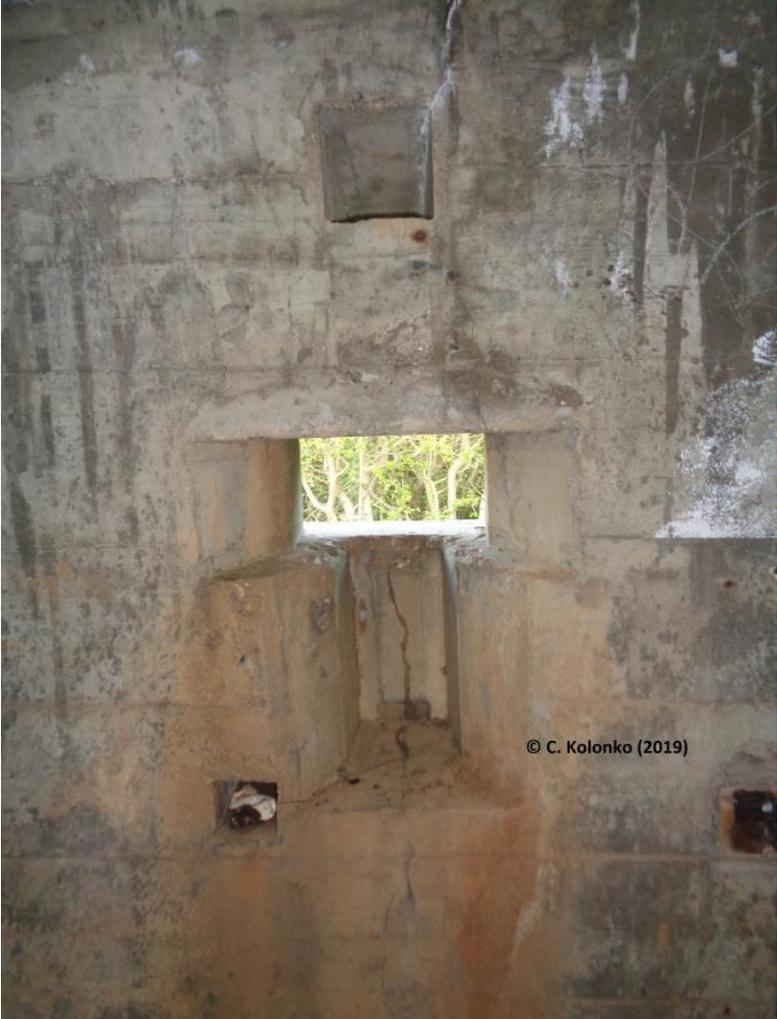
<p>© C. Kolonko (2021)</p>
<p><b>32</b></p>	<p>DSC_1031</p>	<p>Detail of South facing LMG embrasure, showing recess for LMG bipod and vent above loophole.</p>

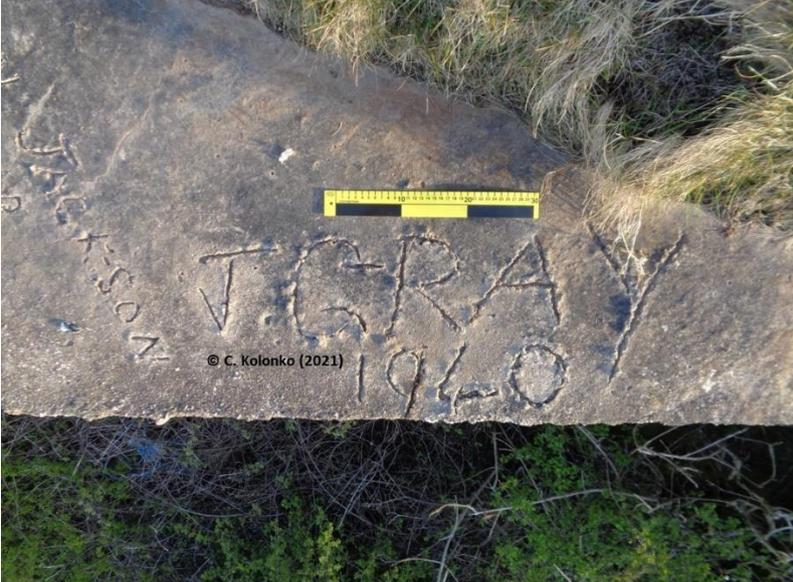
Period graffiti survives on the roof of the pillbox, with several names clearly incised into the still wet concrete during construction. Some of this graffiti sits under the turf camouflage, indicating that either the camouflage was added after the concrete had fully cured, or that the turf has slumped. A total of six names and four dates can be found on the roof of the pillbox:

WALTER 1940  
French 1940  
E Gall  
E.J. MACKSON  
J.GRAY 1940  
Smitts 1940

33	DSC_1032	Detail of graffiti on Northern extent of pillbox roof with 30cm photo scale.

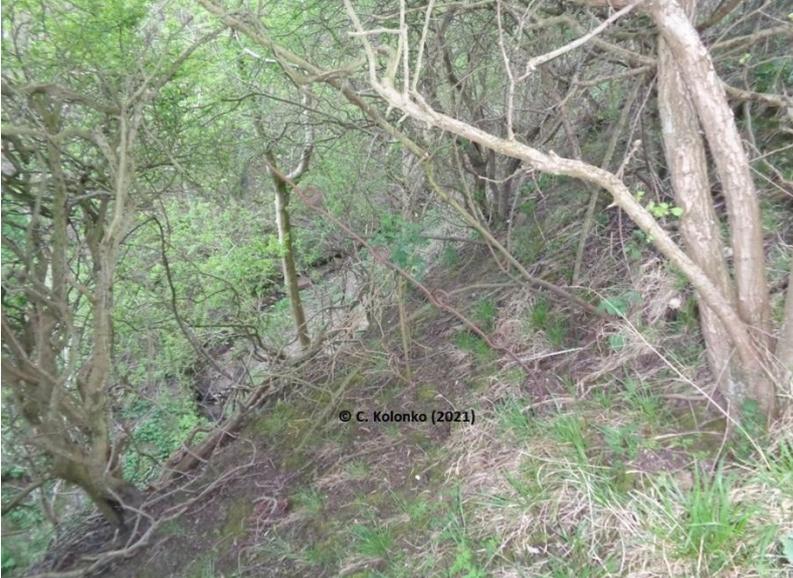
Aerial photographs reveal the pillbox was surrounded by a barbed wire obstacle. A single screw picket from this obstacle survives at Grid Ref: TA 14764 75576. This obstacle would have prevented enemy infantry from closing on the position and getting into grenade throwing range. The pillbox and supporting slit trench were both capable of covering this obstacle with fire.

34	DSC_1033	In-situ screw picket in cliff face to the North of the pillbox at grid TA 14764 75576.

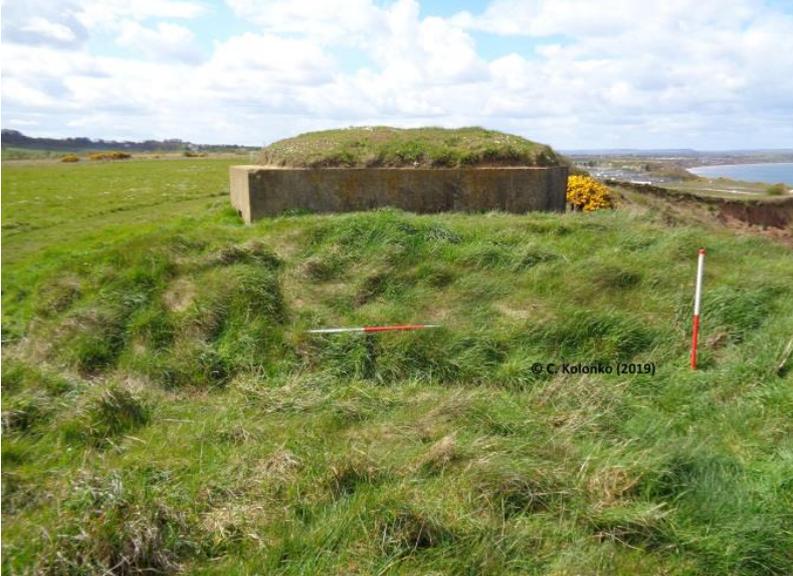
The paradox of a nearby slit trench limits the South-East facing arc of fire, but this area would have been covered by the occupants of the slit trench.

35	DSC_1034	Parados of supporting slit trench obscuring view from South-East facing rifle loopholes. Image taken facing North-West with 1m scales.

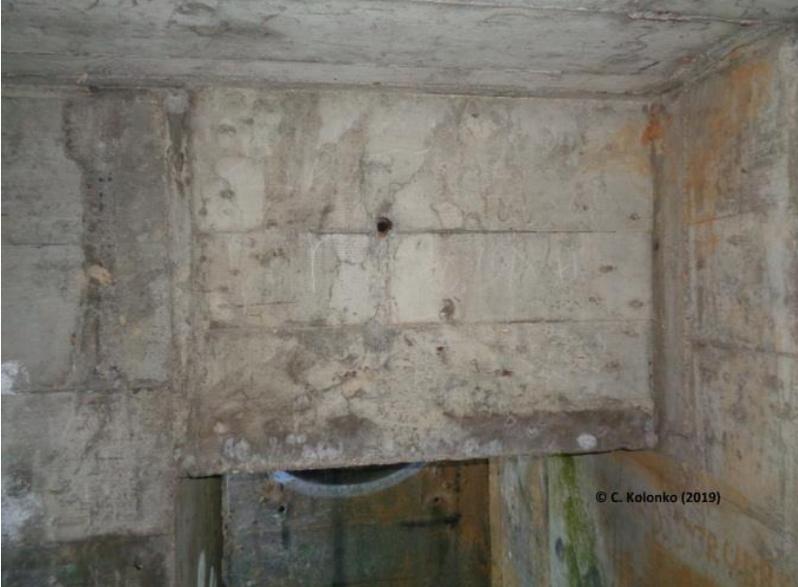
36	DSC_1035	Low lintel above doorway leading to pillbox's central chamber.

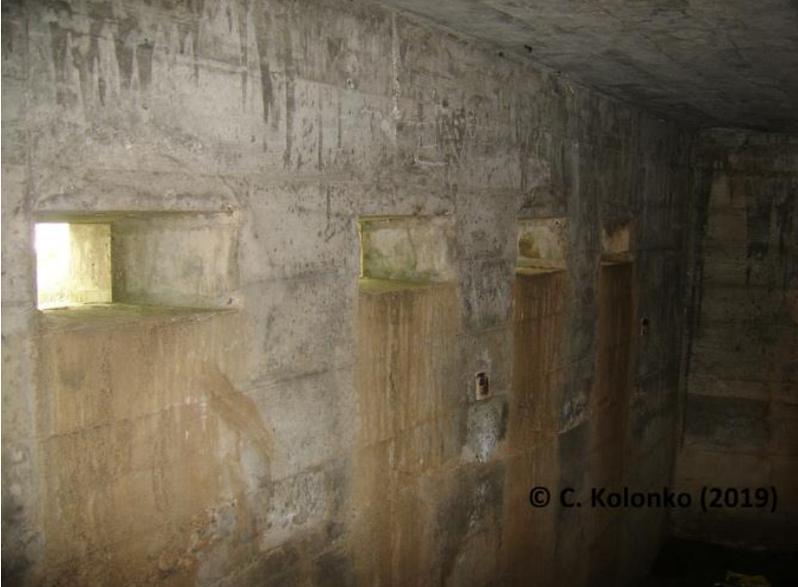
<p>© C. Kolonko (2019)</p>	
37	DSC_1036	Rifle loopholes on interior face of South-East facing elevation. Note lack of recess for LMG bipod.

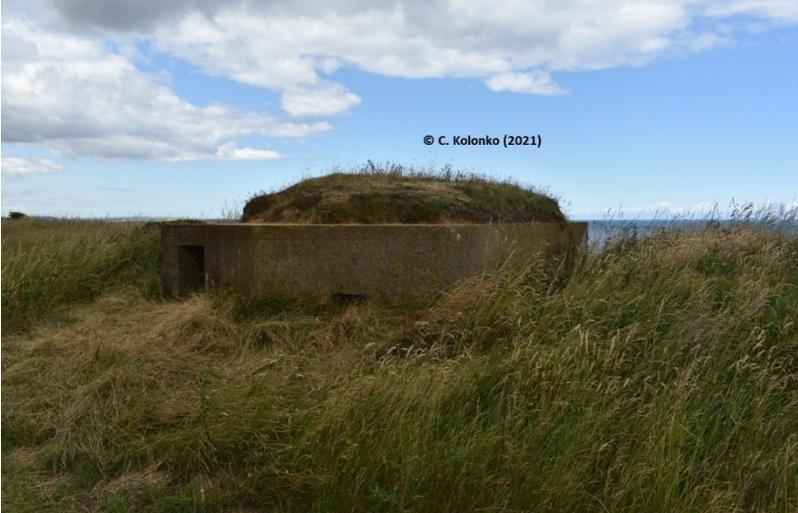
<p>© C. Kolonko (2019)</p>	
38	DSC_1037	General location and form of pillbox at time of survey. Image facing North, showing South and South-East facing elevations.

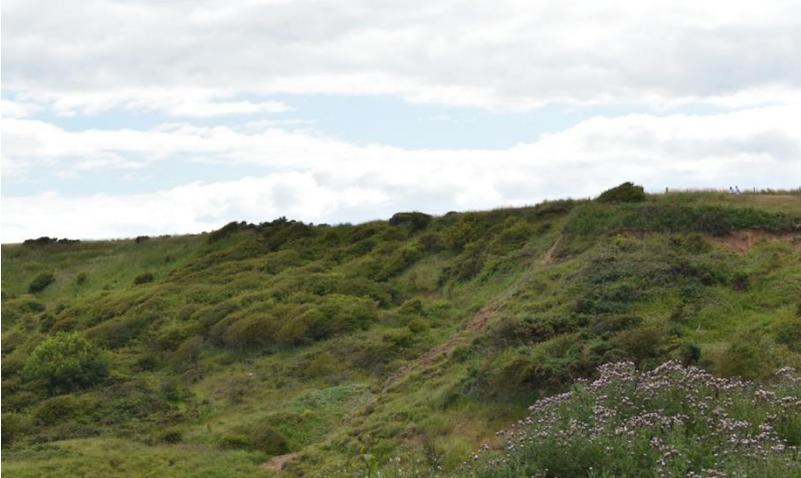
39	DSC_1038	Location of pillbox from approx. 200m North-West. Image facing South-East. Note effectiveness of vegetation camouflage scheme and elevated position.
